International Space Station Crew Quarters On-Orbit Performance and Sustaining Activities

Thilini P. Schlesinger¹ and Branelle R. Rodriguez²
NASA Johnson Space Center, Houston, Texas, 77058

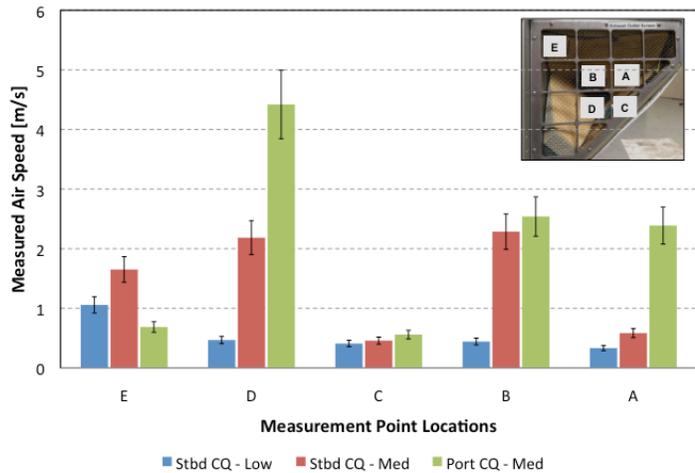
The crew was tasked to record airflow measurements in the starboard and port CQ. Measurements were taken at the intake duct outlet and the exhaust duct outlet as seen in Fig. 2 and Fig. 3 using a Velocicalc[®] ventilation meter. More variability in air speed readings than expected was experienced due to positioning of the instrument, complexity of CQ flow field, air turbulence, and low range of instrument capability. Although solid conclusions could not be made, general conclusions could be extrapolated. The data indicated that the fans were outputting acceptable airflow rates; however, the airflow in the starboard CQ seemed degraded when compared to the port CQ. As a result of this troubleshooting, a detailed CQ fault tree was developed and all possible failures identified. These included: 1) System effects that are causing the airflow sensor to sense low flow (such as foreign object damage); 2) Airflow sensor hardware has been degraded/damaged; or 3) Other system effects such as a failure of the CQ power supply. As the CQ team conducted the failure investigation, the leading candidate for the cause of this anomaly was dirt/dust buildup on the air flow sensors, which would require increased air flow to prevent the alarm from occurring.

Figure 2. CQ on-orbit exhaust duct outlet air speed measurements.

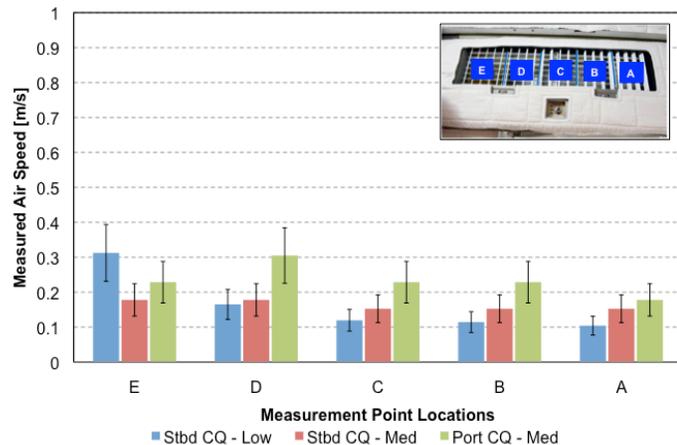
Figure 3. CQ on-orbit intake duct outlet air speed measurements.

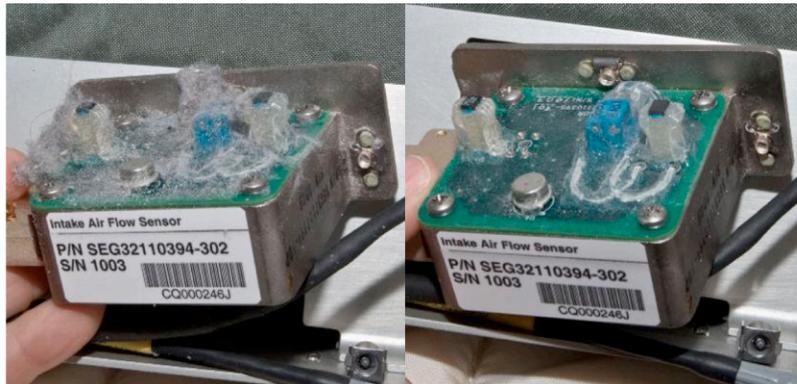
dust on the abatements, flow sensors, and duct surfaces, as photographed in Fig. 4 and Fig. 5. After this thorough cleaning, the fans were set to low speed and the “1 Fan Failed” alarm did not re-annunciate.

Figure 4. Starboard CQ intake air flow sensor (pre- and post-cleaning).

Based on the significant amount of dust accumulation on the sensors, abatements, and fans located in both the exhaust and intake ducts, it was recommended that cleaning of both duct systems be conducted on a regular basis. Regularly scheduled cleaning activities to clean the CQ duct systems have been included in the ISS Preventative Maintenance Assessment, recommending that the intake and exhaust ducts be cleaned every 9 months.

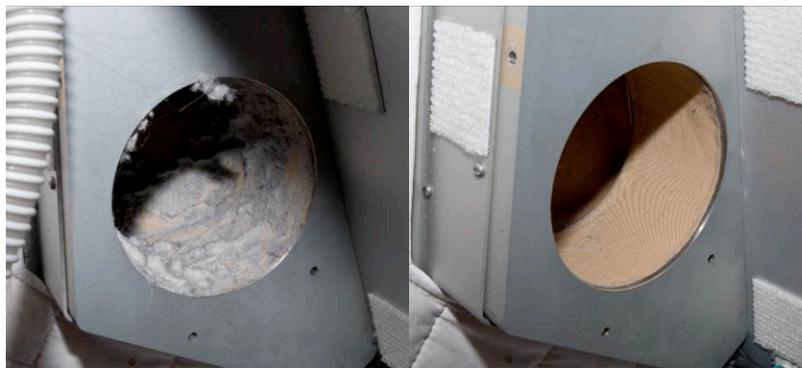
Figure 5. Starboard CQ intake duct (pre- and post-cleaning).

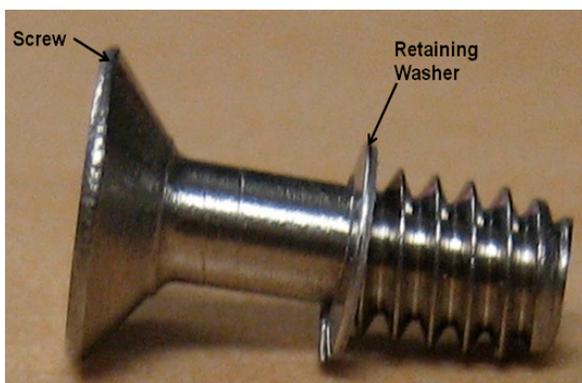
Figure 6. Phillips® head captive machine screw.

Two general types of fasteners became non-captive. One was a Phillips® head captive machine screw and the other was a Live Lock™ stud. For the Phillips® head captive machine screw, the washer (captive feature) is installed by screwing it onto the fastener threads (Fig. 6). Just as it is easily screwed on, if the fastener is loosened out of the substructure but is continued to be loosened against the panel, it is possible to back out (unscrew) the washer during removal. If the crew is removing a panel and is unable to determine whether the fastener is completely removed from the substructure, the crew could continue to loosen the fastener while unfastening the captive washer. It is recommended to remove the Phillips® fasteners one turn at a time to avoid overloosening and backing out the captive washer during removal. For the Live Lock™ Studs (Fig. 7), failure modes include backward installation of the wire form ring (captive feature) on the fastener or the incorrect drill hole size of the retaining ring counterbore.

Backward installation of the captive feature could cause misalignment and possible failure. The incorrect sizing of the counterbore could cause overstressing, thereby leading to failure. Build paperwork and drawings show that the correct instructions were given for the installation of these fasteners, but there is not enough detail on individual fastener inspection to determine whether one of the above issues occurred.

All four of the CQ cleaning procedures have been updated to instruct the crew to loosen the Phillips® head captive machine screws one turn at a time to prevent the washers (captive features) from backing out during removal. The procedure also instructs the crew that the fasteners are susceptible to becoming non-captive and, therefore, the crew should show care when un-installing to prevent fasteners from getting lost. Spares are available on the ground to replace the captive features for all four types of fasteners, but it is not recommended that they be replaced at this time.

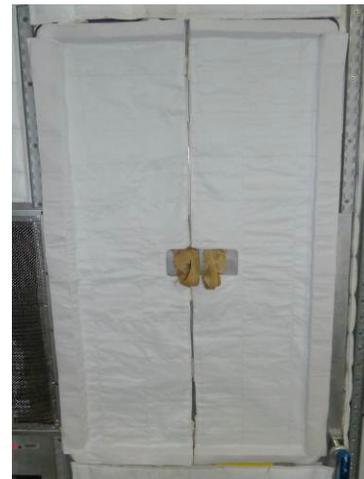
Figure 8. Cover installed on CQ exterior doors.

In early 2011, a blanket replacement plan was recommended by the CQ project and approved by the ISS Program. A crew contact assessment was performed to investigate the possible contact on each blanket. This led to the identification of “low contact” and “high contact” areas. High contact areas were defined as locations where crew contact was seen daily (for example, doors, laptop area). Low contact areas were defined as locations where crew contact was minimal. The replacement plan recommended replacing low frequency crew contact blankets approximately every 5 years and covering high frequency crew contact blankets with covers (Fig. 8) approximately every 3-1/2 years. The covers would be attached on top of the existing blankets to protect the blankets from spills and wear. The covers do not contain any acoustic mitigation material. They consist of one layer of Nomex® and one layer of Gore-Tex®, identical to the outer layers of the acoustic blankets. In addition, the covers use and provide the same crew attachment points, such as grommets and Velcro®, as the current blankets. By developing lighter-weight covers instead of replacing the high frequency crew contact blankets, 16 kg and 0.16 m³ of upmass and volume could be saved for the four CQs. One set of spare blankets and two sets of covers were manufactured in 2011 and early 2012. In July 2012, H-II Transfer Vehicle 3 delivered the first set of blanket covers to the ISS. The remaining covers are currently in stowage until required on-orbit.
