THE INITIAL FLIGHT ANOMALIES OF SKYLAB I

By the NASA Investigation Board

63-SECOND ANOMALY: LOSS OF METEOROID SHIELD

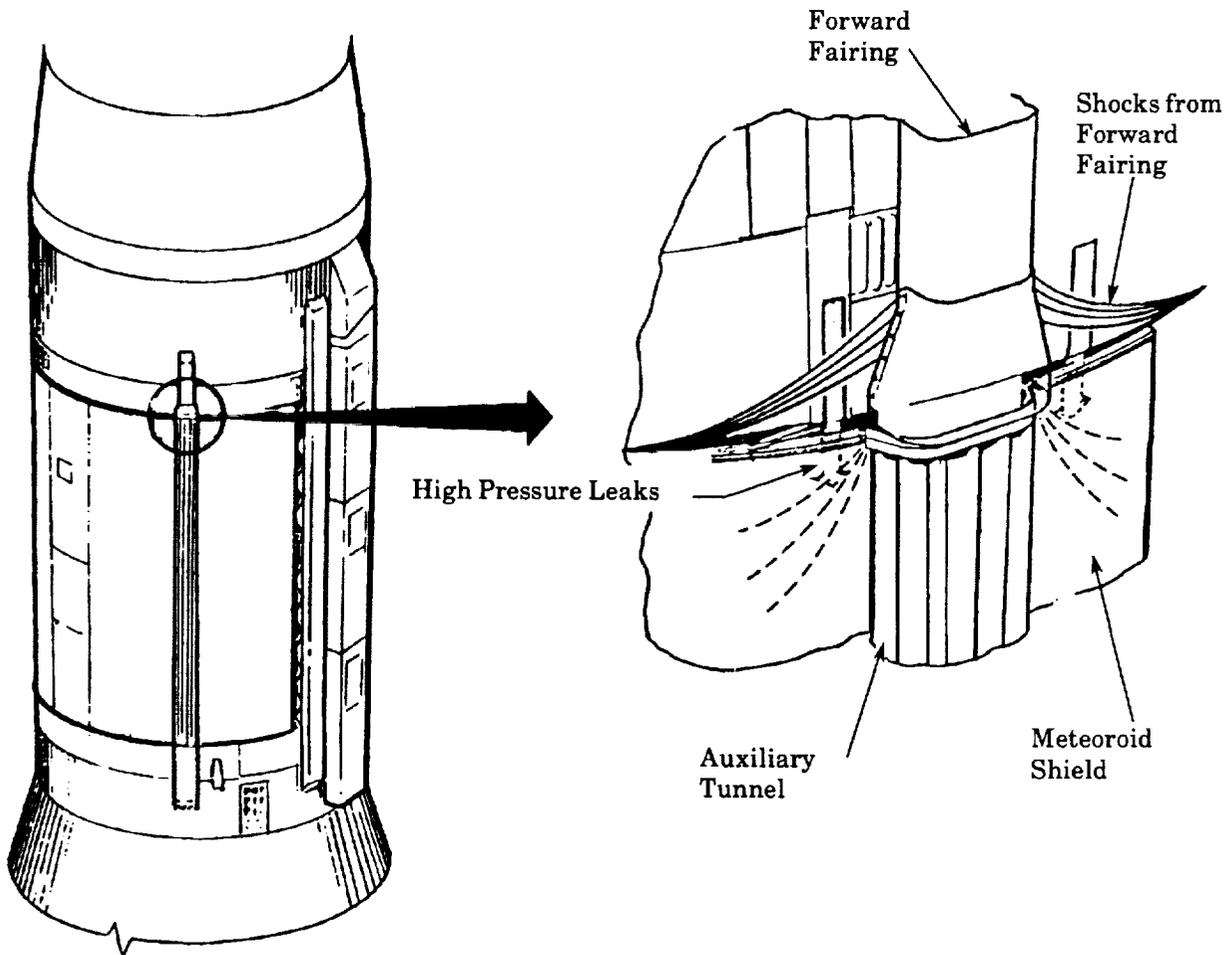
Figure 3 Compressibility waves from the forward auxiliary tunnel fairing

Among these other modes of potential failure, which could combine in various ways under varying conditions of flight, are excessive pressures under the forward edge of the shield, or inadequate venting of the folded ordnance panel. The inherently light spring force of the auxiliary tunnel frames, the crushing loads on these frames in flight, the inherent longitudinal flexibility of the shield assembly, the forces applied by the swing links to deploy the shield, the possible breathing of the shield panels as cavities are vented, the noncylindrical nature of the underlying pressurized tank, and the uncertain tension loads applied to the shield in rigging for flight all contribute to a lack of rigidity of the shield and a weakness of its structural integrity with the underlying tank structure.

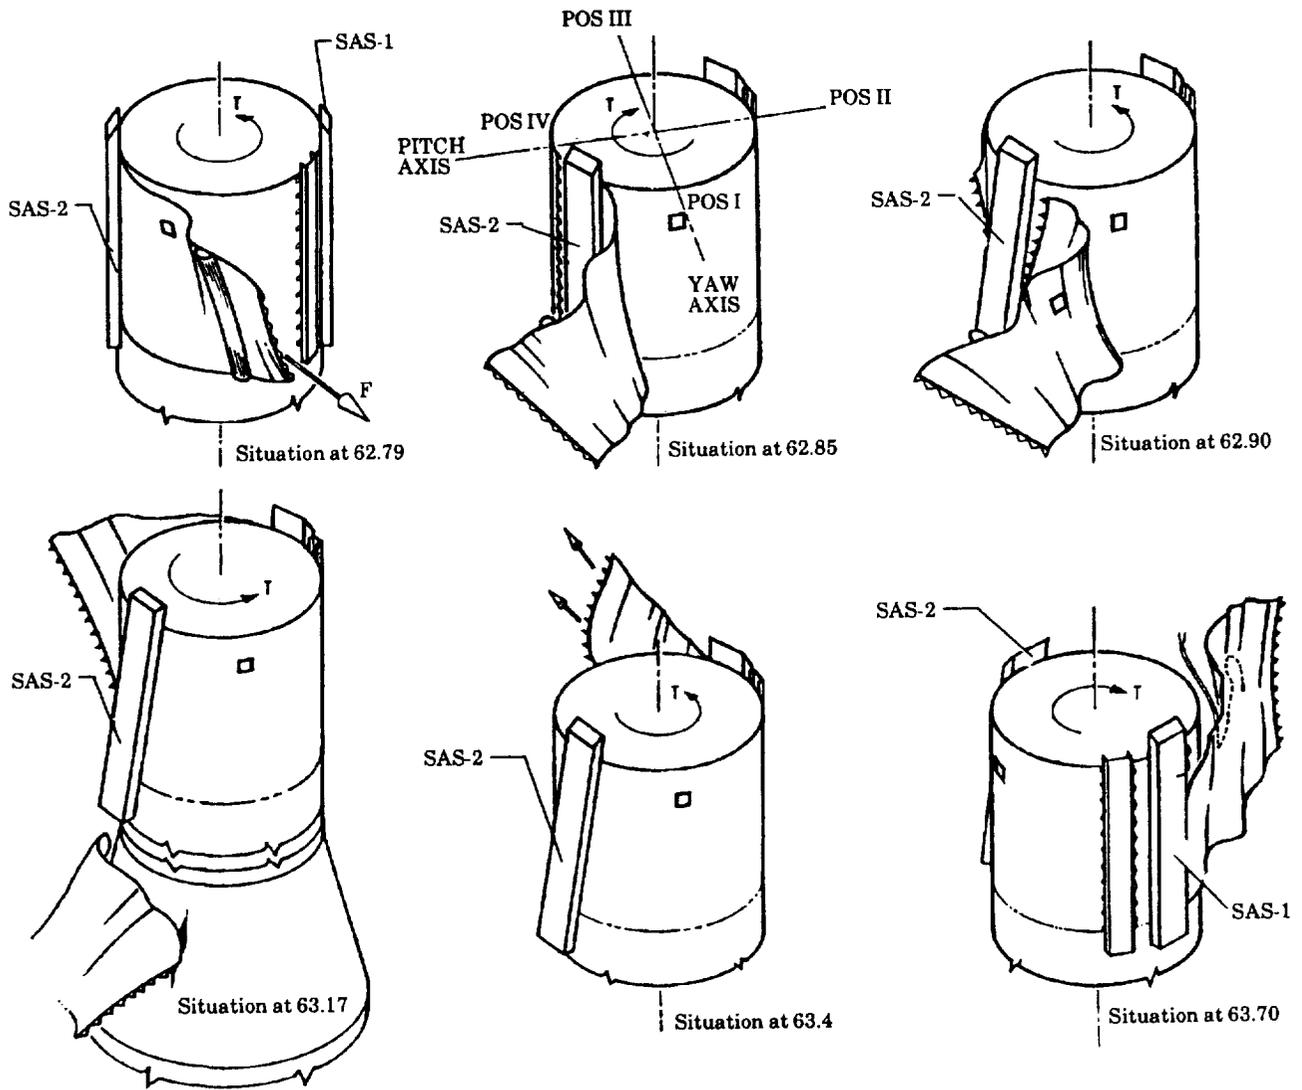
Figure 4 — Postulated Sequence Failure Mode

62.74 to 62.79 Seconds - Burst pressure under the auxiliary tunnel and adjacent meteoroid shield caused a large tangential load on the forward section of the butterfly hinge, causing the whole hinge to unzip. Fly around inspection indicated that the failure of the butterfly hinge occurred at the hinge line adjacent to the main tunnel.

The butterfly hinge was now completely broken. Aerodynamic drag on the meteoroid shield including the bulky auxiliary tunnel produced tension in the shield and pulled on the vehicle so as to roll it in the direction shown, that is, opposite to that noted earlier. The large area and mass of this metal flag induced a more rapid change in roll rate than the earlier jetting through the butterfly hinge. This process terminated as the meteoroid shield started to wrap around and lift the SAS-2 wing.

62.79 to 62.90 Seconds - During this interval the shield was wrapping around the SAS-2 wing producing a negative roll torque in the vehicle. At about 62.85 seconds the SAS-2 tie-downs were broken.

62.90 Seconds - Upon release of the SAS-2, the tension in the shield was transferred to the trunnions, causing failure of the trunnion straps. Upon separation of this section of the shield, the negative roll torque ended.

- 4) The most probable cause of the failure of the meteoroid shield was internal pressurization of its auxiliary tunnel. This internal pressurization acted to force the forward end of the tunnel and meteoroid shield away from the orbital workshop and into the supersonic air stream. The resulting forces tore the meteoroid shield from the orbital workshop.
