THE INITIAL FLIGHT ANOMALIES OF SKYLAB I

By the NASA Investigation Board

63-SECOND ANOMALY: LOSS OF METEOROID SHIELD

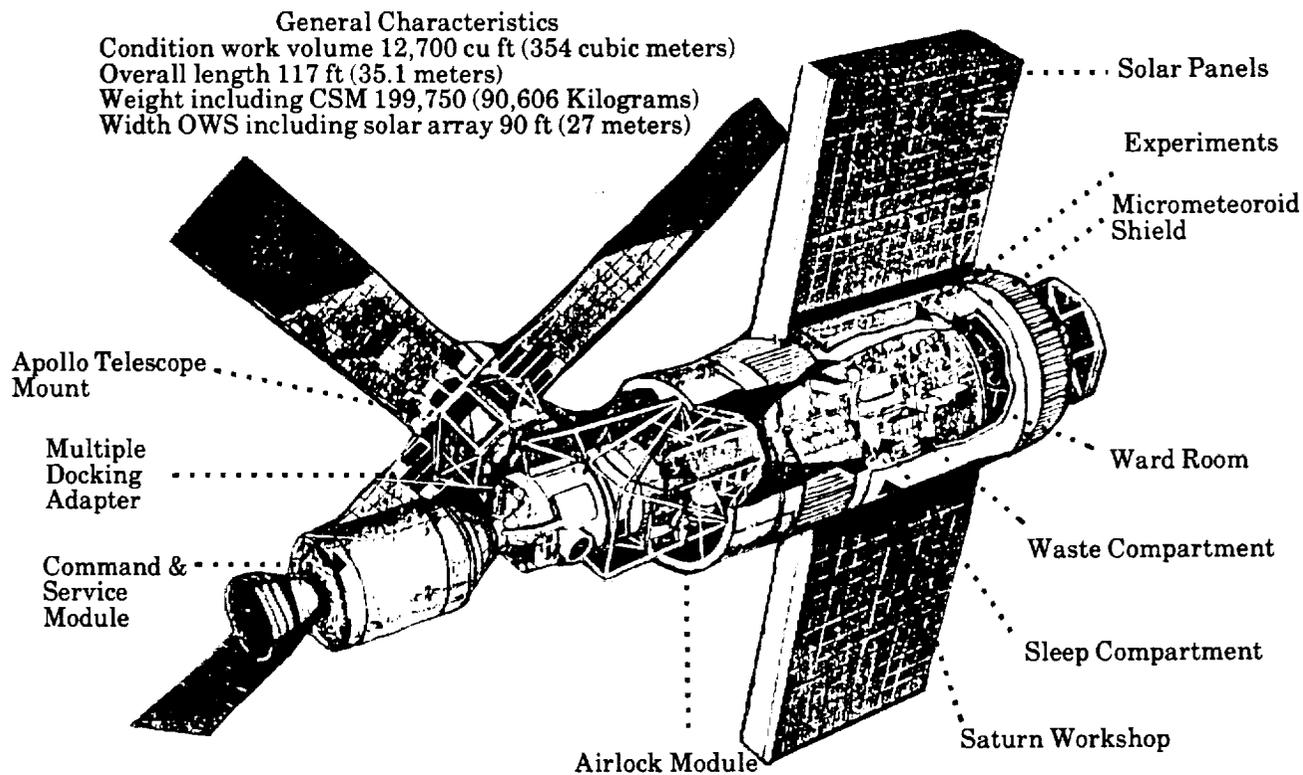
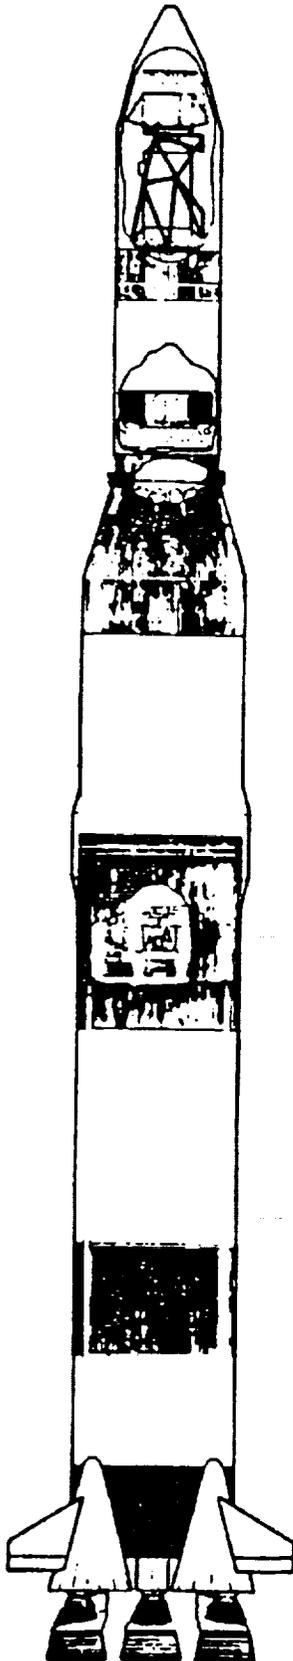
Figure 1 Skylab Cluster

Figure 1 shows the Skylab in orbit. Its largest element is the orbital workshop, a cylindrical container 48 feet long and 22 feet in diameter weighing some 78,000 pounds. The basic structure of the orbital workshop is the upper stage, or S-IVB stage, of the S-IB and S-V rockets which served as the Apollo program launch vehicle. The orbital workshop has no engines, except attitude control thrusters, and has been modified internally to provide a large orbiting space laboratory and living quarters for the crew. The Skylab 1 (SL-1) space vehicle included a payload consisting of four major units—orbital workshop, airlock module, multiple docking adapter, Apollo telescope mount—and a two-stage Saturn-V (S-IC and S-II) launch vehicle as depicted in Figure 2. To provide meteoroid protection and thermal control, an external meteoroid shield was added to cover the orbital workshop habitable volume. A solar array system (SAS) was attached to the orbital workshop to provide electrical power.
